Manhole Inspection Summary

Manhole # S13S__007MH

Insp Date: **3/13/08 9:00 AM**

Location Address: **3102 Wilkens Ave**

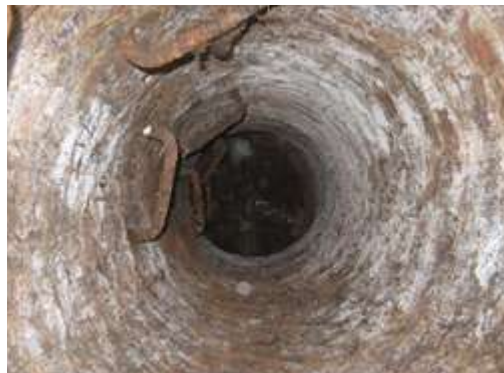
Top View

view @12oclock, defect corroded steps

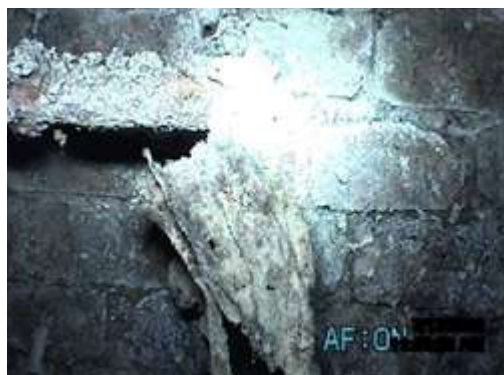
Defect 2

evidence of surcharge

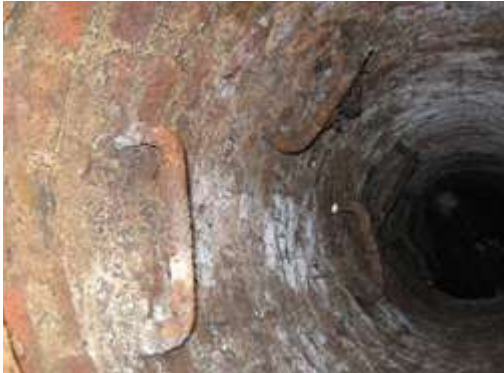
Defect 1

corroded steps, corbel and barrel
infiltration

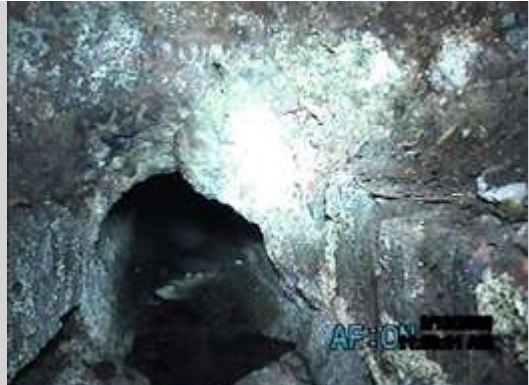
12 O'Clock Outflow

Pipe Height: **8.4** (in.) Rod and Bar (Angled)
Pipe Material: **Clay** ☐ Pipe Lined
Invert Depth: **16.30** (ft.) Flow Characteristics: **Slow**
Deposits: ☐ None ☒ **Mud** ☒ **Sludge** ☒ **Debris** ☐ Grease
Silt Depth: **3** (in.) Deposits Extent: **Light**
Infiltration: **None** Pipe Seal Cond: **Unknown**

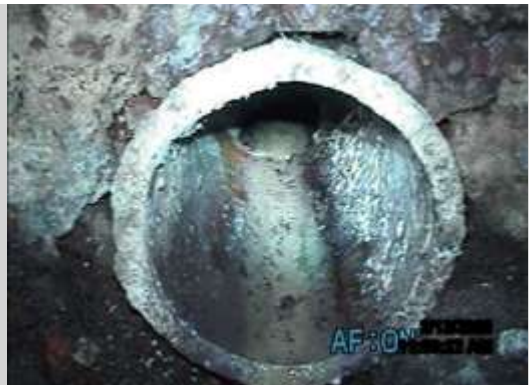
4 O'Clock Inflow

Pipe Height: **8.4** (in.) Rod and Bar (Angled)
Pipe Material: **Clay** ☐ Pipe Lined
Invert Depth: **16.00** (ft.) Flow Characteristics: **Slow**
Deposits: ☐ None ☒ **Mud** ☒ **Sludge** ☒ **Debris** ☐ Grease
Silt Depth: **3** (in.) Deposits Extent: **Light**
Infiltration: **None** Pipe Seal Cond: **Unknown**

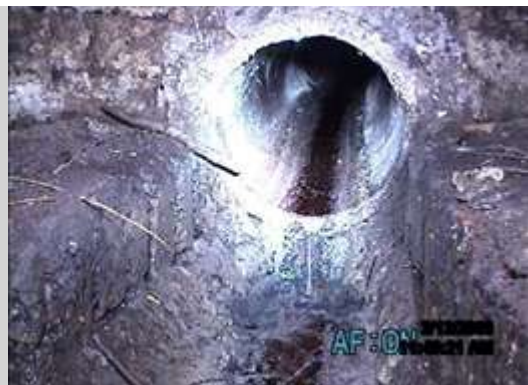
6 O'Clock Inflow

Deposits: ☐ None ☒ **Mud** ☒ **Sludge** ☐ Debris ☐ Grease

Silt Depth: **5** (in.) Deposits Extent: **Light**
